**NO NAME 550 DAM
WASHINGTON COUNTY, MISSOURI
MO 30711**

**PHASE 1 INSPECTION REPORT
NATIONAL DAM SAFETY PROGRAM**

MISSOURI INVENTORY NO. 30711

PREPARED BY
INTERNATIONAL ENGINEERING COMPANY, INC.
CONSULTING ENGINEERS
SAN FRANCISCO, CALIFORNIA

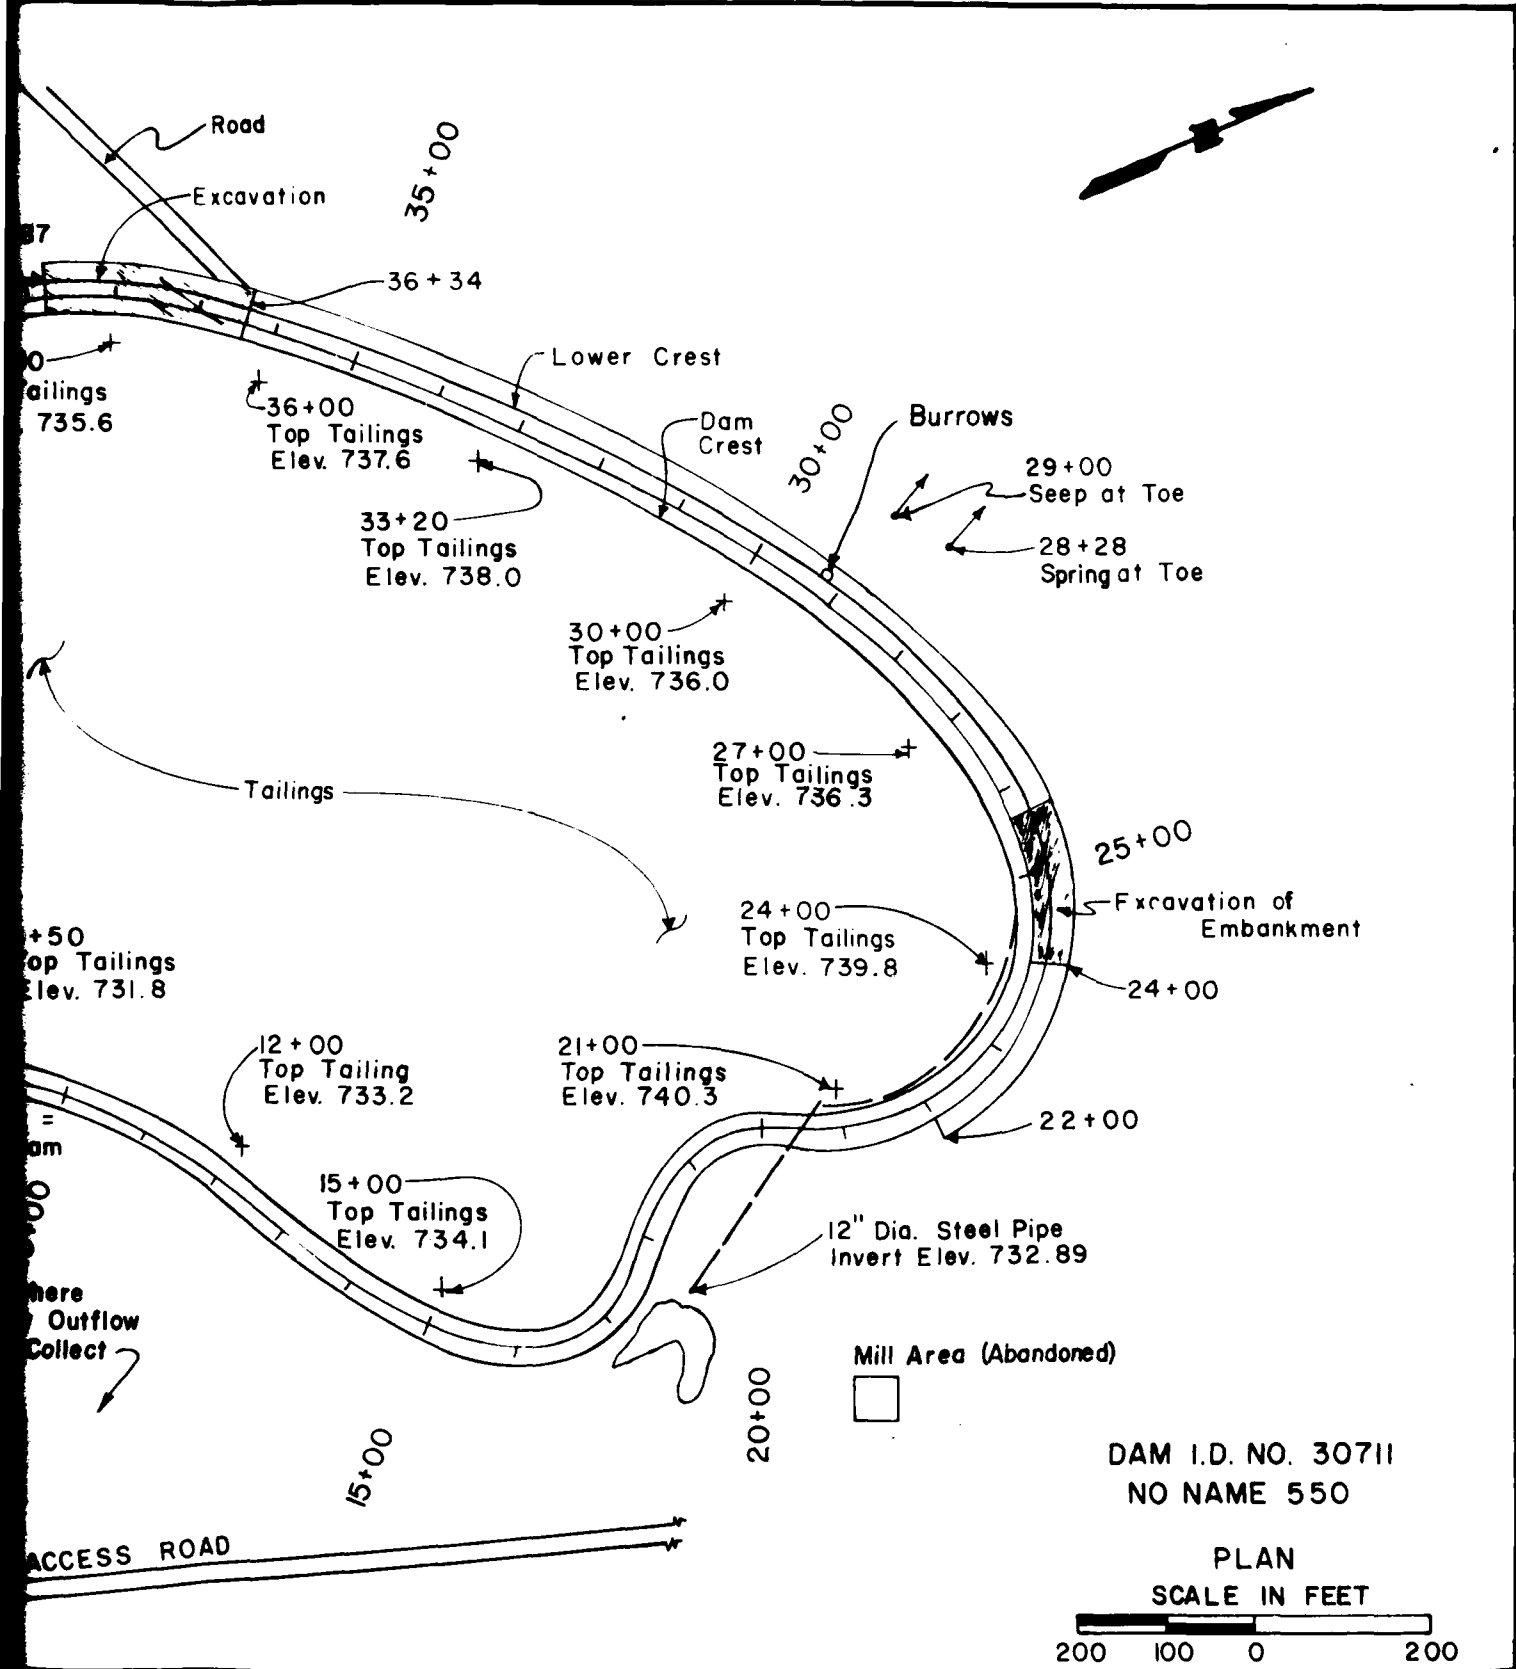
PLATE 3

c. Dam. The plan of the dam is shown on Plate 3. Profiles and sections are shown on Plates 4, 5, 6, and 7. A little vegetation is growing on the slopes of the dam. Some trees were buried during the dam enlargement process, and these were exposed in places on the downstream slope of the dam.

An inactive 12-inch diameter pipe from the mill site enters the embankment at Station 20+60 and extends along the crest in broken sections to Station 25+00. Location of this line is shown on Plate 3. No diversion ditches are located at the damsite.
